DOT/FAA/CT-94/116

# Vertical Drop Test of a Narrow-Body Fuselage Section with Overhead Stowage Bins and Auxiliary Fuel Tank on Board

Final Report

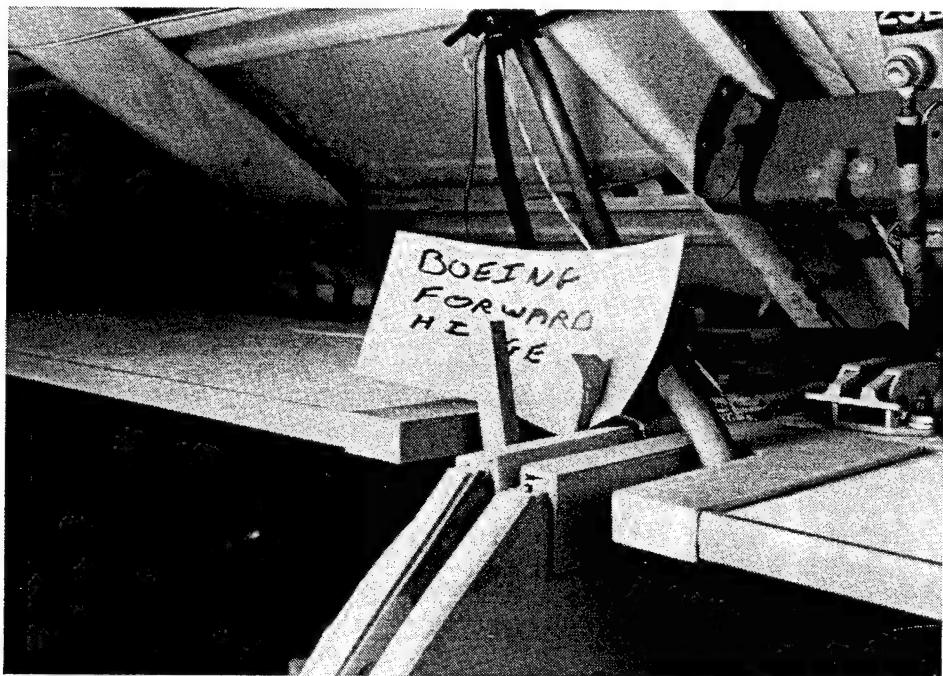
- a. The personal service units (PSUs) detached from the bin prior to the primary impact pulse.
- b. Both door hinges fractured. The contents in the center compartment did not spill due to the plastic strap, which was added for this test, placed around the door and bin.
- c. Five support links, out of a total of 15 links, were damaged after the primary impact pulse. Four links were broken, two instrumented (17B and 28B) and two noninstrumented (one placed on the bottom of the bin at BS1145 and

FIGURE 43. BOEING BIN BROKEN FORWARD HINGE, POSTTEST

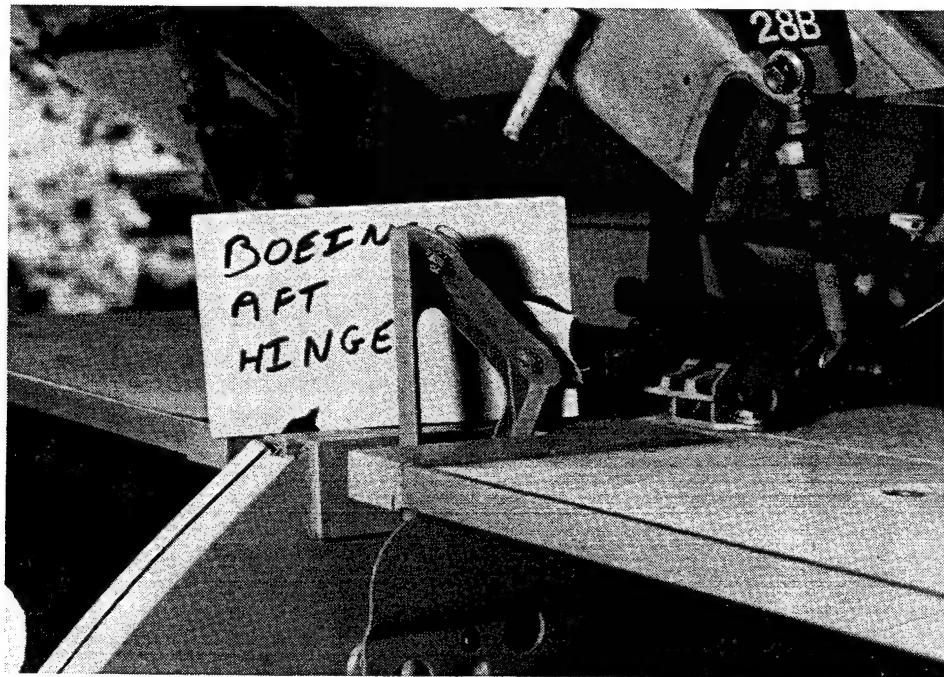
FIGURE 44. BOEING BIN BROKEN AFT HINGE, POSTTEST
